Troubleshoot Multicast Traffic Not Passing through FTD Firewall with Bidir PIM Configuration

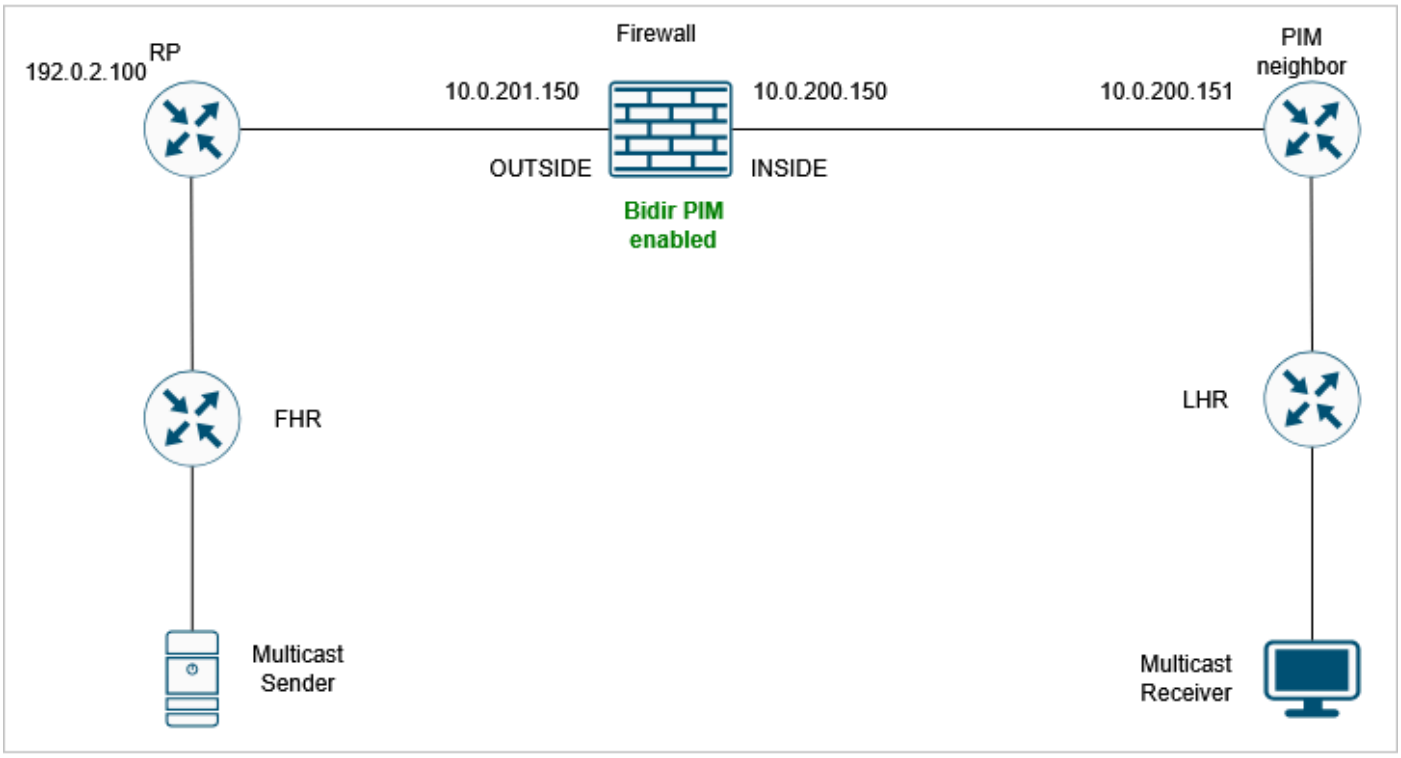
- Multicast traffic stopped working on Firewall Threat Defense (FTD) for a specific multicast group.
- There are no multicast routes (mroutes) on the FTD for the group (224.2.2.2 in this example).

show mroute 224.2.2.2

No mroute entries found.
device#
```

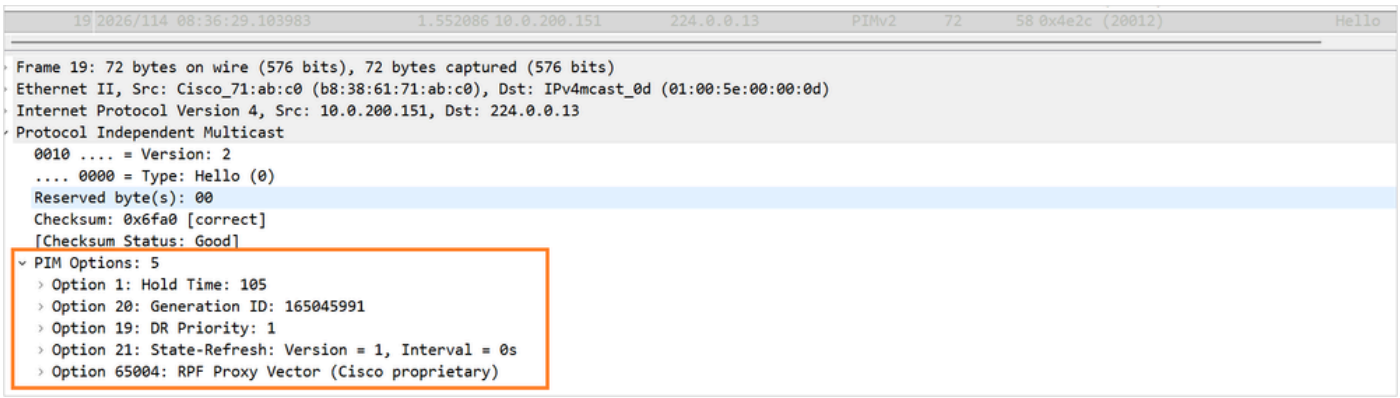
Source capture name [CAPI]?
Destination filename [CAPI.pcap]?
%Warning:There is a file already existing with this name
Do you want to over write? [confirm]
!
28 packets copied in 0.0 secs
```
