Troubleshoot BGP Flaps Between Ultra Packet Core and Nexus Switch Due to Incorrect Configuration

This document describes the solution to the Border Gateway Protocol (BGP) flaps between Cisco Ultra Packet Core (UPC) and Nexus 9000 switch configured with redundant BGP connection.

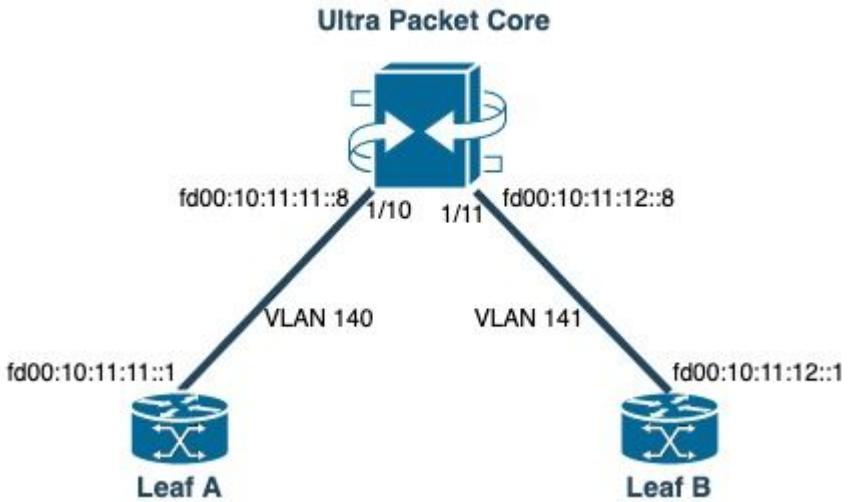
Figure 1: Network Diagram

BGP flaps are triggered when one of the redundant interfaces between the Cisco Ultra Packet Core and Nexus switch flaps.

The Ultra Packet Core (UPC) node is connected to Nexus Leaf A and Leaf B on separate ports. The BGP IPv6 peers are established and the default routes are installed on the UPC node. Figure 1 shows the high-level network diagram with redundant path to Leaf switches.
