Troubleshooting Guide for Cisco NCS 1010, IOS XR Release 7.10.x

First Published: 2023-08-18

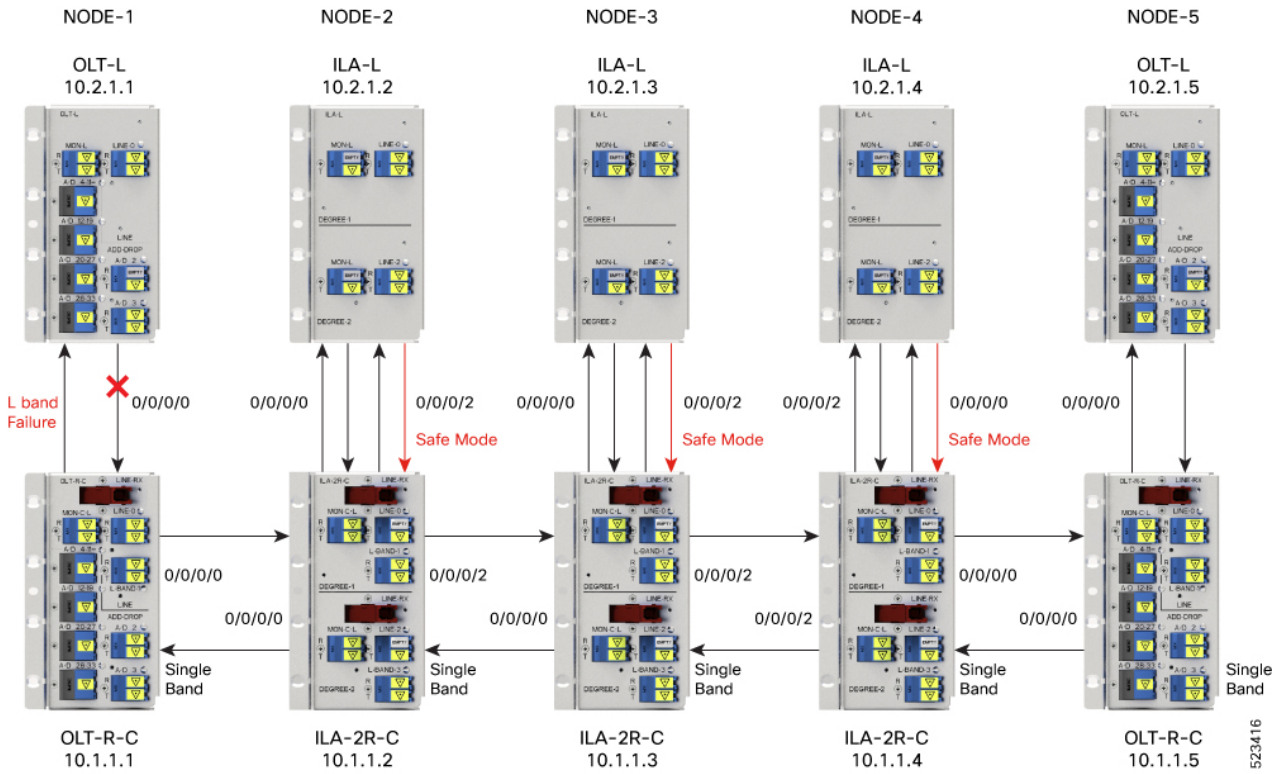
Figure 1: Example of L-band Failure

In this section, we will troubleshoot L band failure due to connectivity failure between OLT-C and OLT-L nodes. To troubleshoot L-band failure on a C+L band network, start by running the following commands on the manager nodes:

The following command example shows the status of all the L-band nodes as FAILED which indicates that the issue is between the L-band devices of nodes 10.2.1.1 and 10.2.1.2.

Hence, from steps 2 and 3 outputs, we can conclude that the connectivity failure is between the OLT-L node10.2.1.1 and ILA-L node 10.2.1.2, and the *Loss Of Continuity* alarm confirms the fiber failure between the nodes 10.2.1.1 and 10.2.1.2.

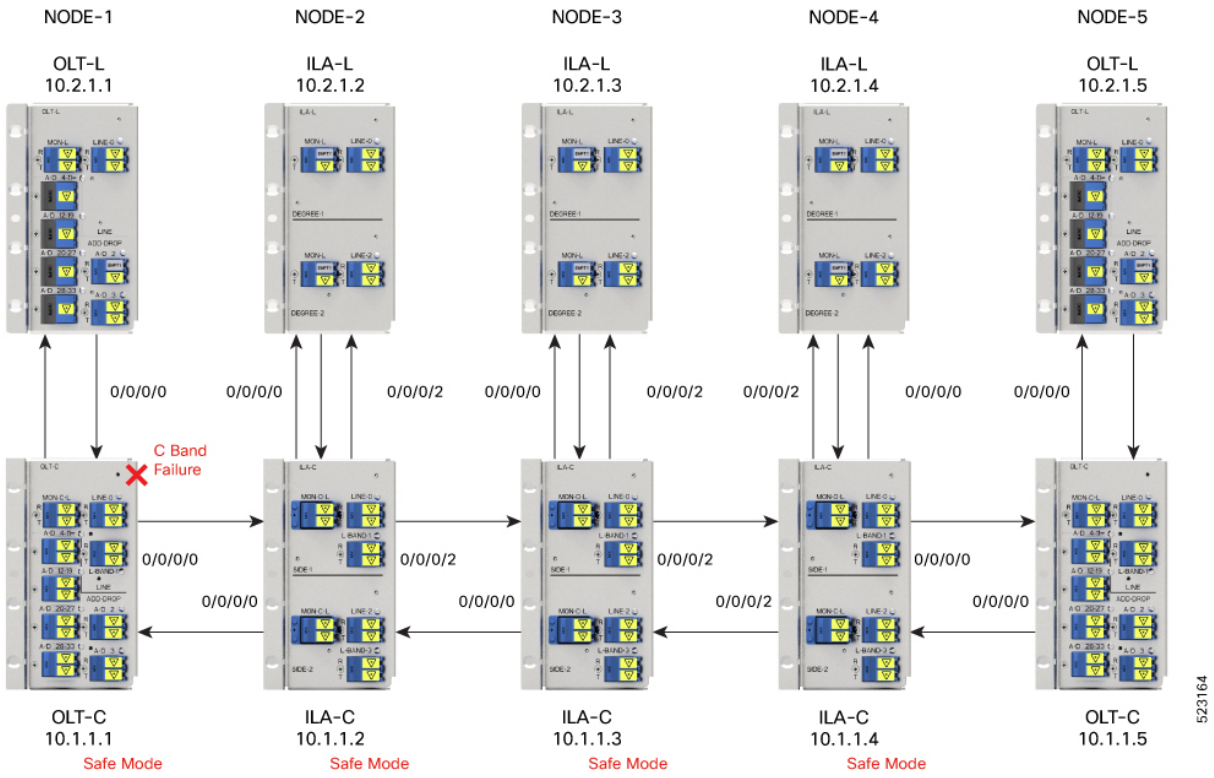
Figure 2: Example of C-band Failure on a C+L Band Network

In this section, we will troubleshoot C band failure due to amplifier shutdown or failure. To troubleshoot C-band failure on a C+L band network, start by running the following commands on the manager nodes in the same order:

The following command example shows the status of all the C-band nodes as FAILED which indicates that the issue is between the C-band devices of nodes 10.1.1.1 and 10.1.1.2.

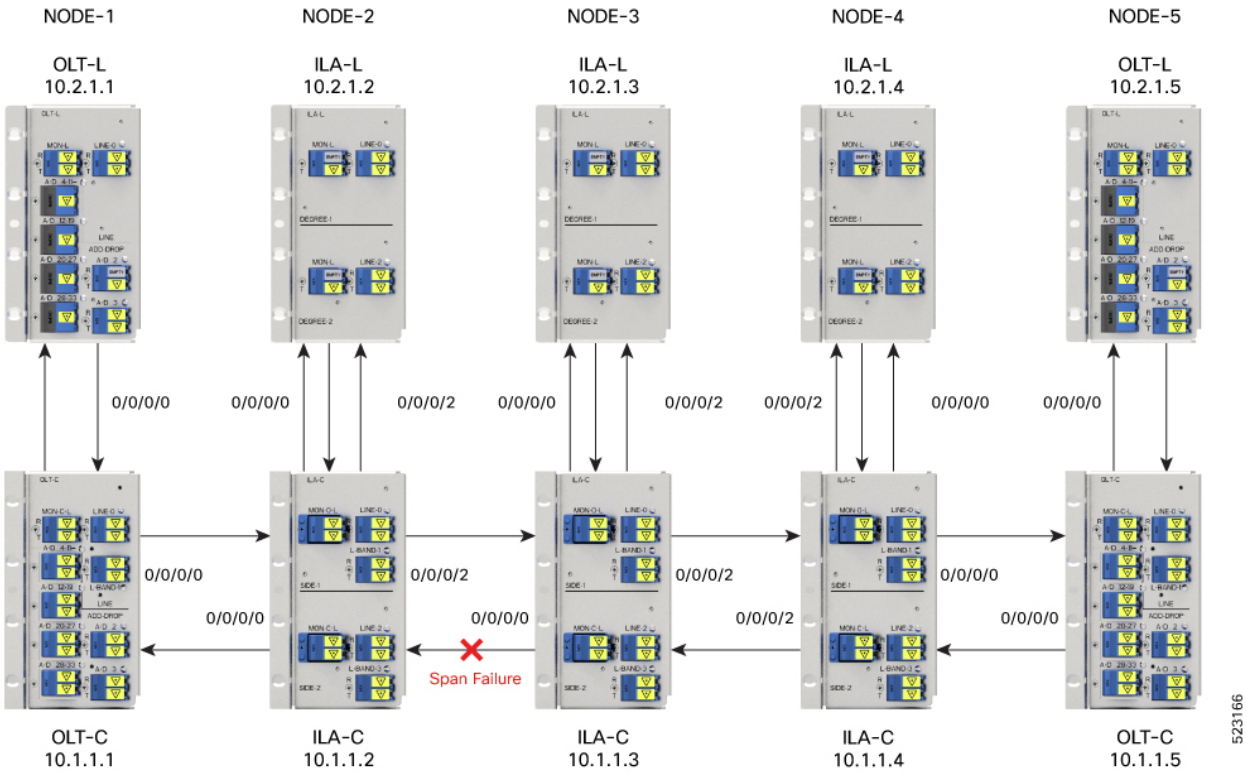
Figure 3: Example of Span Failure

To troubleshoot span failure on a C+L band network, start by running the following commands on the manager nodes in the same order:

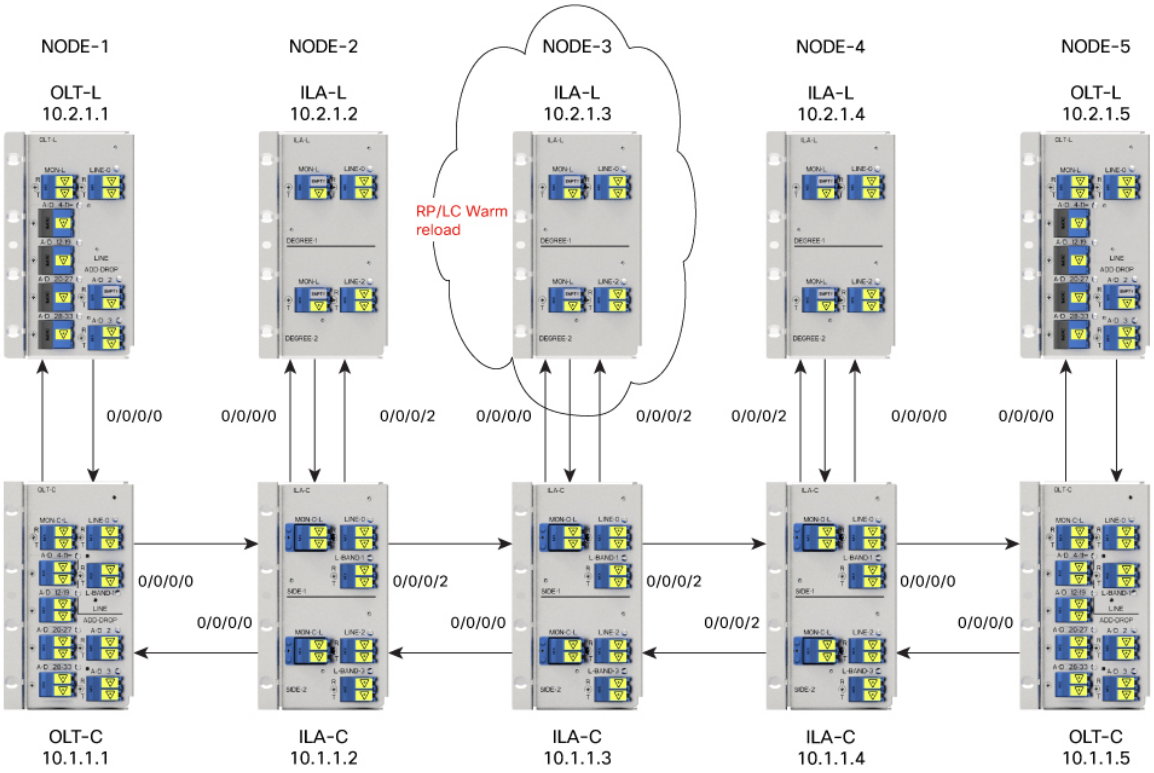
Figure 4: Example RP or LC Warm Reload Troubleshooting on C+L Band Network

On a C+L band network, RP or LC warm reload on a C or L band device might affect the partner band connectivity. In this case, traffic is not impacted. To troubleshoot a RP or LC warm reload on a C+L band network, following these steps:

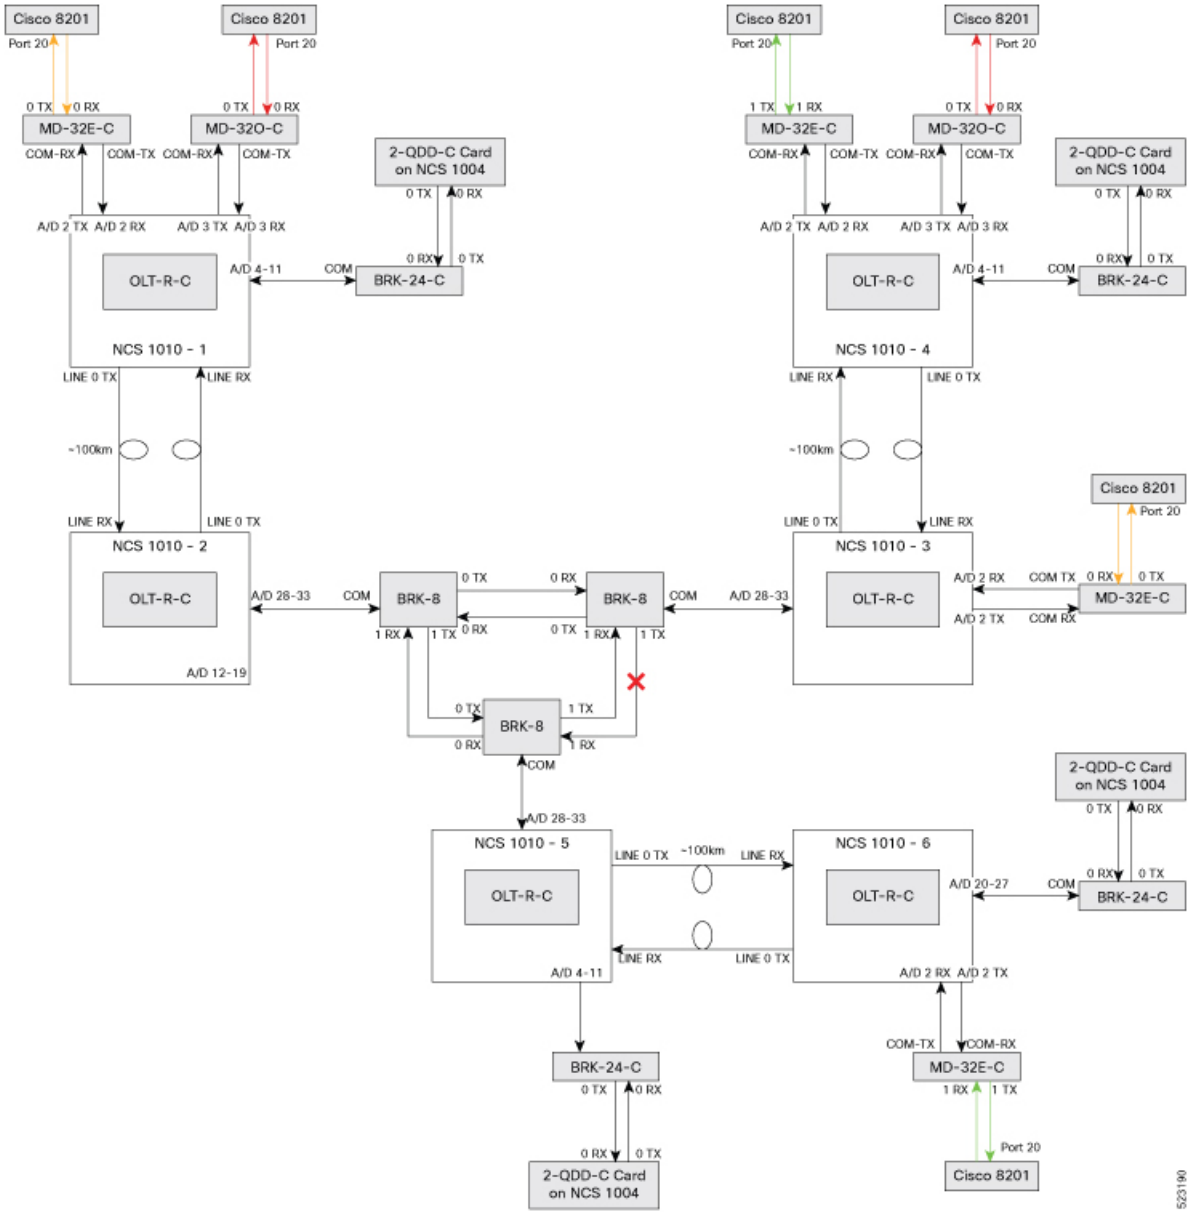
Figure 5: Fiber Cut Between Two Passive Devices

The following figure displays the fiber cut between two passive devices:
